THE FORENSIC ENGINEERING REPORT

A \$3 ITEM.....A \$90,000 LOSS

Sea Strainer Pipe Fitting Failure

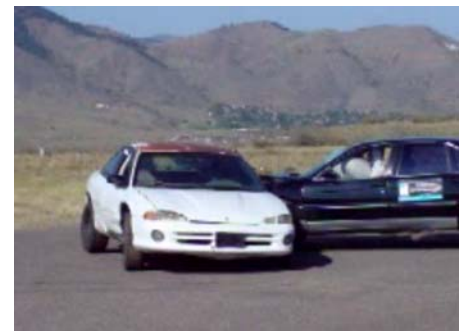
Image of the 90-degree impact of the test vehicle with the target vehicle. Note the inflated driver's airbag.

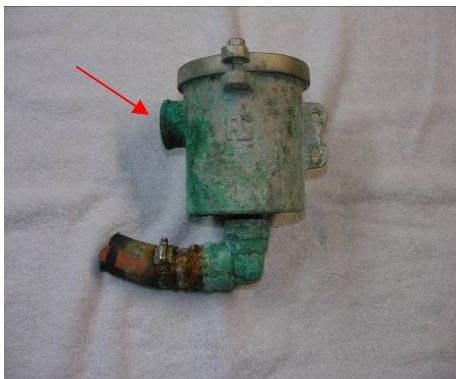
Photo P-1

Our assignment at Trnka Engineers Co. was to determine the cause of the fitting failure. The cause of the failure could possibly provide the basis for subrogation of the claim. The evidence, the sea strainer and pipe fitting, was provided to us by the adjuster as seen in Photo P-1. The broken fitting location is indicated by the red arrow.

A quick 10x magnification inspection of the broken pipe fitting gave us cause to suspect that a brass pipe fitting was used in the sea water cooling system where bronze, a more appropriate pipe fitting material, should have been used.

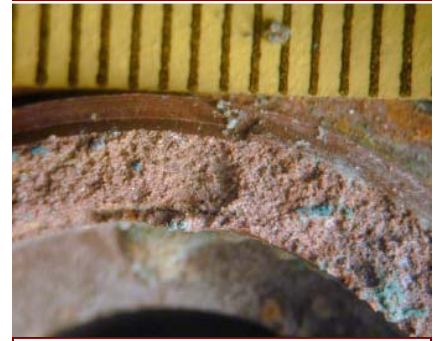
Photo P-3

A closer view is seen in the Photos P-2 and P-3. Note the “spongy” appearance of the fractured pipe fitting surface in Photo P-3. The spongy appearance occurs with the migration of the zinc out of the copper base material of the pipe fitting.

The laboratory findings did indeed confirm the fitting to be brass and dezincification did occur as a result of exposure to sea water. This finding was then reported to the adjuster who now had opportunity to subrogate back to the yacht builder.

Note the “Spongy” Appearance

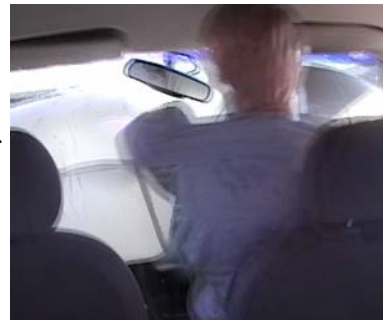
A sequence of in-car images taken during the crash test. Note that both driver and passenger airbags were deployed, protecting the otherwise vulnerable crash dummy from an uncertain fate. No dummies were harmed in the creation of these images.
