THE FORENSIC ENGINEERING REPORT

VOLUME 12, ISSUE 3

VENTILATION: SIMPLE CONCEPT BUT OFTEN FORGOTTEN

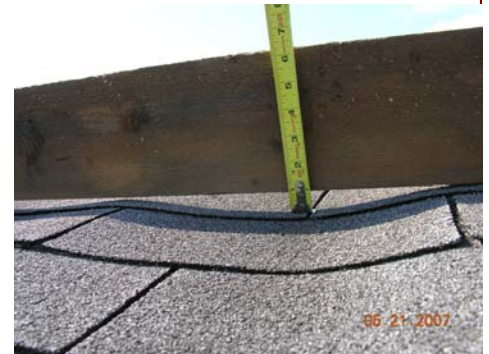
Another common finding during our investigations of ventilation problems is in homes with cathedral ceilings. We like cathedral ceilings for the reason of making our homes feel larger and more open. What we have discovered however, is that since there is no attic space in a cathedral ceiling design it often occurs that the space between the roof sheathing on the exterior and the wallboard on the interior is stuffed with insulation. The insulation effectively blocks passage of air from the soffit openings to the ridge vents therefore moisture cannot evacuate this space. The moisture then fosters the mold growth and eventually the wood structure begins to decay.

Example of collapsing roof sheathing due to moisture induced wood rot above a cathedral style ceiling.

The simple solution during construction is to leave enough air space above the insulation so air can freely pass and with it carry away the damage causing moisture. The contractor must also take care to avoid blocking the soffit openings under the eave of the roof.
