THE FORENSIC  
ENGINEERING REPORT

VOLUME 13, ISSUE 1

**SAMPLE "EVERY DAY" CASES INVESTIGATED  
BY THE I-ENG-A NETWORK**

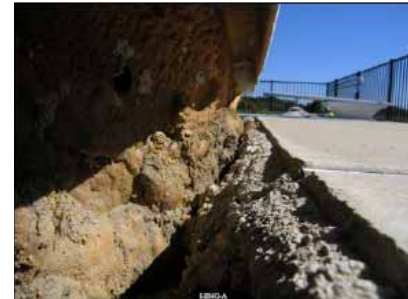
**CASE #1  
HOT-TUB POP-OUT**

This residence had a hot-tub installed 8 years prior to the loss. The acrylic hot tub popped out of place six inches exposing the underside of the pipes with large voids under the concrete slab. The hot tub failure was alleged to have been caused from a water overflow condition from the adjacent pool and spa.

Determination: It was determined that the damage to the spa was in-fact due to long term erosion under the patio slab over the course of time due to improper compaction and a lack of anchoring.

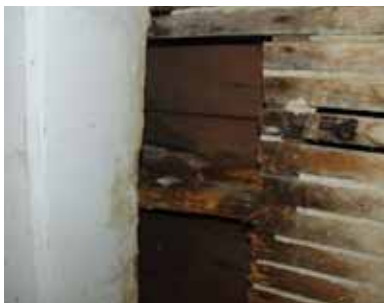
**CASE #3  
MOLD ORIGIN AND CAUSE**

This residence reportedly had mold growth in the bathroom located at the left corner of the building. The material in the area was considered plaster over wood lath. The wood showed evidence of being soft and damp and there was evidence of long-term deterioration of the wooden material. A cast pipe was located within this wall.

An examination was made in the basement and the pipe was part of the sewage system. This vent or discharge line led to the main sewer line and led to the exterior of the building.

A moisture meter noted evidence of dampness which, was from condensation or deterioration of the subject sewer line. The investigator felt the line with his hand and it showed evidence of being scaled and corroded.

A further examination was made of the exterior of the building at the roof level and it was noted that the pipe which vented through the roof had evidence of deterioration to the related material.

In conclusion, the subject water damage and growth within the wall itself was a direct result of long-term deterioration of the sewer vent/supply line. No single event or accidental event caused the damage.

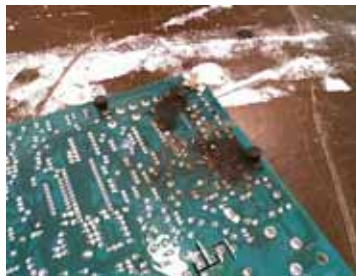
**CASE #4  
AIR CONDITIONER  
LIGHTNING DAMAGE or NOT?**

This HVAC unit was retrieved from a junkyard for inspection for lightning damage. Upon inspection of the condensing unit, black burn marks were found on the contact points. Normal arcing inside the switch caused this type and amount of damage. As the switch aged the arcing gradually became worse.

An ohmmeter was placed on the capacitor and the reading was 26.7 microfarads. This reading is due to normal age. The capacitor was still in the working range. There were no shorts found on the condenser and it was in working order. The heater/blower unit checked out ok as did the fan blower motor.

The motherboard did have damage due to an electrical short which was the cause of the overall failure of the HVAC unit.

It was determined that the unit had not been struck by lightning and could have been repaired with a new motherboard. The cost of the board is around \$257.50 assuming 2 hours of service at \$60/hr + tax, the repair bill is estimated to have been \$402.51.

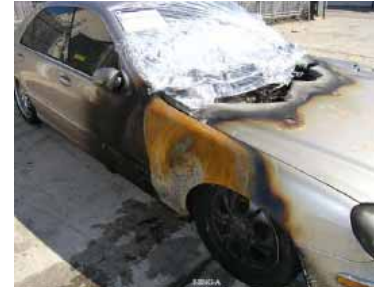
**CASE #5  
VEHICLE FIRE INVESTIGATION**

The subject vehicle was a 2000 Mercedes Benz S500 four-door sedan. Overall examinations revealed evidence of fire damage and scorching to the right front fender and partial consumption of the hood. The damage was primarily noted to the back portion of the hood or area near the windshield. The windshield sustained significant heat damage and had failed during the course of the fire.

All of the tires remained, however the right front did sustain some flame and heat damage. No evidence indicated a prior collision. No evidence of forced entry or impact damage. Ignition assembly remained intact. Examinations were performed of each compartment of the vehicle to eliminate potential causes of the fire.

The concluding opinions and fire patterns indicated that the fire originated in the engine compartment along the rear bulkhead wall area.

Two potential scenarios exist. The first is that the transmission fluid dipstick was not replaced during the recent service, in the retainer and allowed heated transmission fluid to back up through the tube and enter the engine compartment where it was able to ignite off a hot component of the engine.

The second was that the active body control distribution hose had deteriorated and hydraulic fluid discharged into the engine compartment and ignited. This failure is involved in a current recall campaign issued by the National Highway Traffic Safety Administration (NHTSA).

At this point a joint inspection was recommended so that all interested parties can jointly examine the vehicle (the service company and the manufacturer of the vehicle).

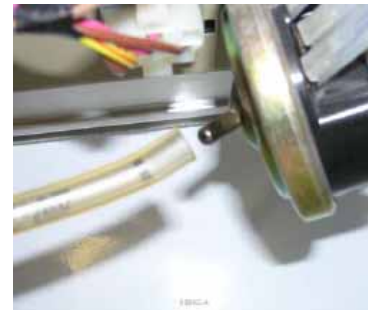
**CASE #8  
WASHING MACHINE FAILURE?  
WATER DAMAGE CLAIM**

The purpose of the assignment was to examine the washing machine to determine if it was responsible for water damage in the structure.

The concluding opinions, based on analysis and evaluation of the washing machine, indicated that the tube between the wash tub and the pressure switch separated at the pressure switch control panel. This prevented the compression of air in the tubing to activate the pressure switch allowing water to continuously fill the tub and crest the top of the tub. The separation could have been prevented by adding a small clamp or fastener around the tube and pressure switch nipple. The responsibility should lie with the manufacturer of the washing machine.
