# The I-ENG-A Report

## Grain Bin Collapse - Wind or Other Phenomena ??

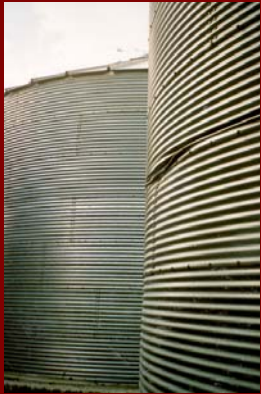
**Grain Bin  
Damage:  
Claimed to be  
the result of high  
wind pressure.**
